ANNUAL REPORT FOR 2011

Bailey Branch Site D Mitigation Site
Madison County
TIP No. R-2518A

Prepared By:
Natural Environment Unit & Roadside Environmental Unit
North Carolina Department of Transportation
December 2011

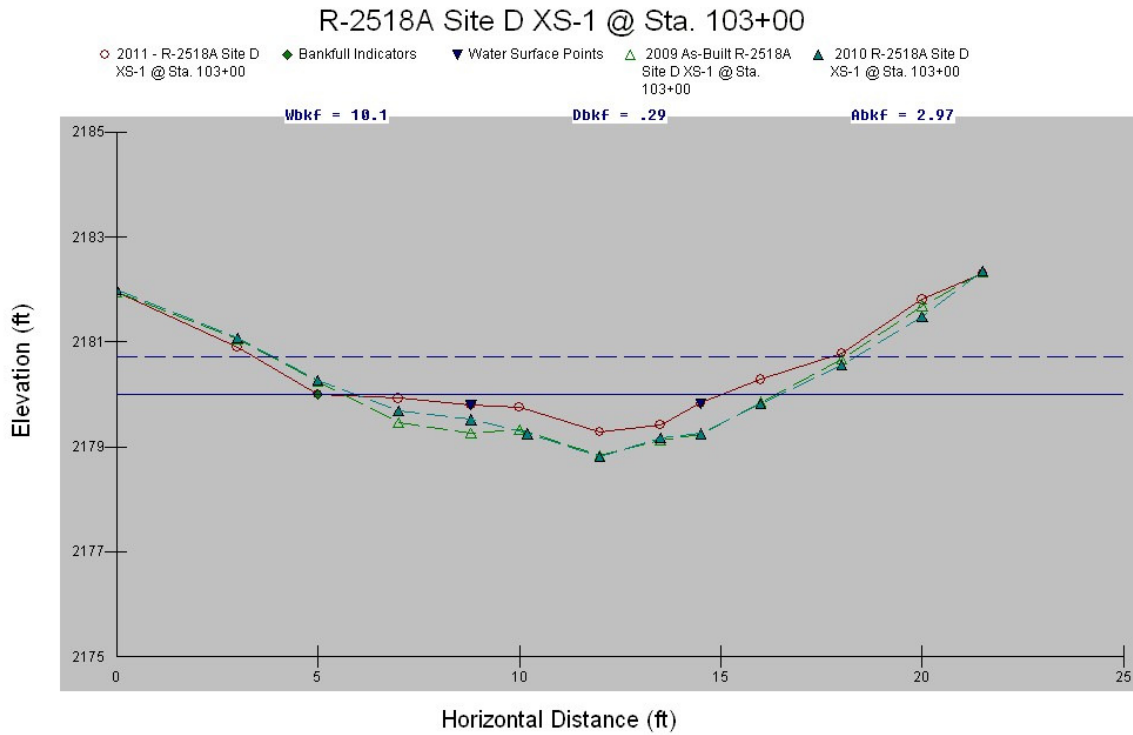
Site D: Cross-Section #1 (Riffle) Abbreviated Morphological Summary					
	2010	2011	2012	2013	2014
Bankfull Cross Sectional Area (ft ²)	9.61	2.97			
Maximum Bankfull Depth (ft.)	1.45	0.71			
Width of the Floodprone Area (ft.)	19.54	14.32			
Bankfull Mean Depth (ft.)	0.79	0.29			
Width/Depth Ratio	15.47	34.72			
Entrenchment Ratio	1.6	1.42			
Bankfull Width (ft.)	12.22	10.07

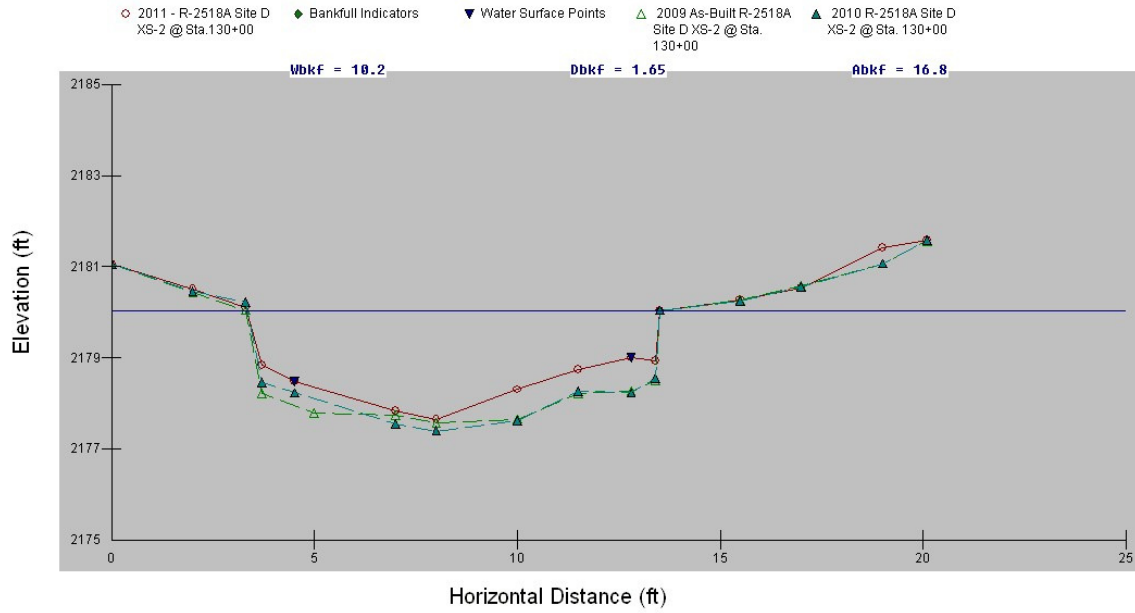
R-2518A Site D XS-2 @ Sta.130+00

Site D: Cross-Section #2 (Pool) Abbreviated Morphological Summary					
	2010	2011	2012	2013	2014
Bankfull Cross Sectional Area (ft ²)	21.23	16.78			
Maximum Bankfull Depth (ft.)	2.65	2.38			
Bankfull Mean Depth (ft.)	2.09	1.65			
Bankfull Width (ft.)	10.16	10.17
